e-Journal of New World Sciences Academy
2012, Volume: 7, Number: 2, Article Number: 1A0323

Zuhal Şimşek

COMPARATIVE ANALYSIS OF TWO MAJOR HOSPITAL FIRES

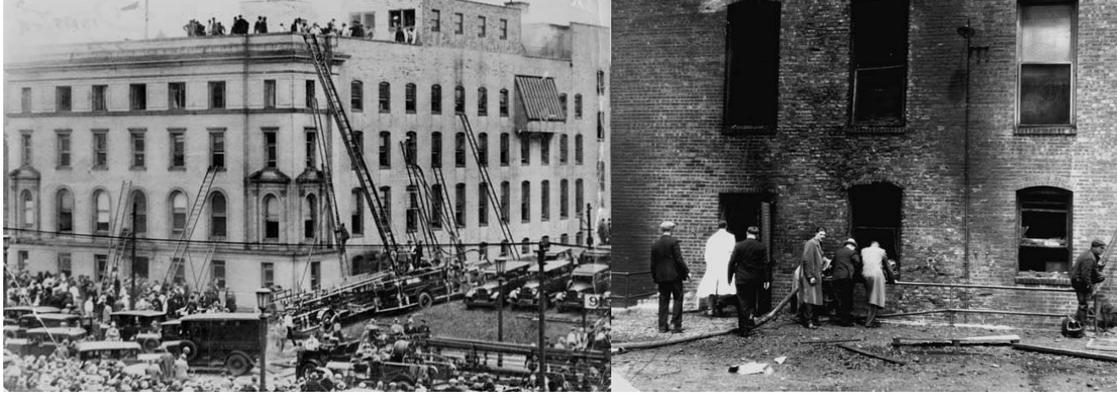
to escape due to heavy smoke leaned out of the windows as a last resort until rescued. The fact that there was adequate space around the hospital building to carry out the rescue work and that the fire squad had responded to the the fire very quickly prevented a bigger disaster (Figure 1) [14].

Figure 1. Fire extinguishing and rescue Works
(Şekil 1. Yangın söndürme ve kurtarma çalışmaları [13])

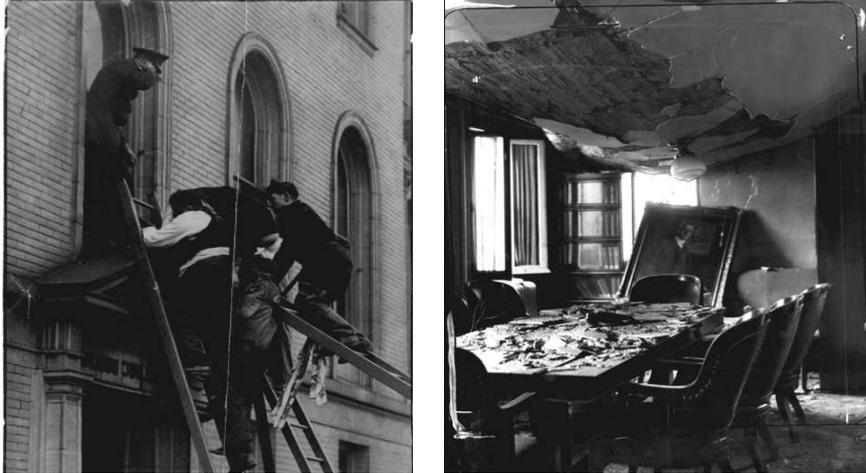
After the fire was noticed, 2 alarms were turned in to the fire department within 4 minutes and a third alarm was turned in 10 minutes later. The odor of burning nitrocellulose from the hospital was noticed before the fire squads were dispatched. The rescue work progressed very slowly due to the concentration of fumes and poisonous gases. This caused the rescue teams to go back and put on oxygen masks. Most of the employees and patients in the hospital who did not have oxygen masks have lost their lives due to poisoning at this stage. The fire had spread very quickly to six adjacent locations through combustible material and curtains (Figure 2). The elevator shaft adjacent to the archive room in particular, transmitted the smoke to all floors. Explosions have occurred at the roof when the fumes running through the ventilation and heating ducts under pressure contacted oxygen at the roof. The machine room which was adjacent to the archive room was also effective in these explosions by pressurizing the gases [13].

Figure 2. Patient evacuation and interior images of the explosion took place

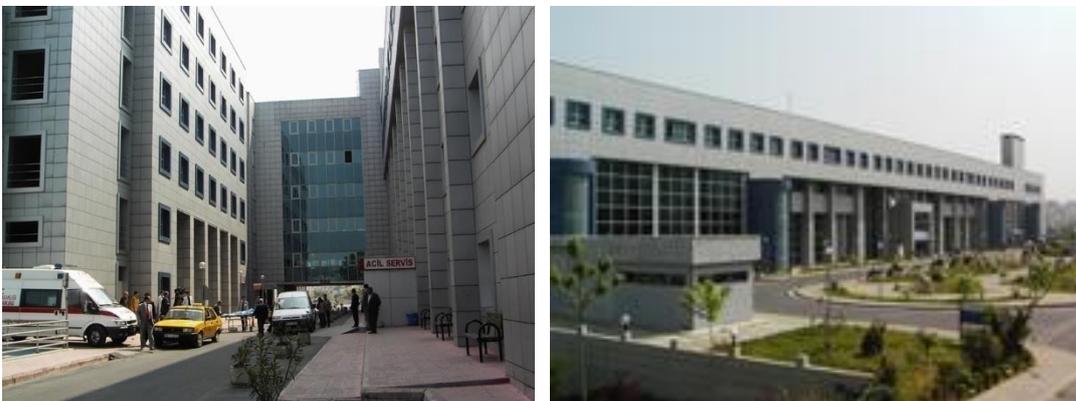
The fire started on 26 May 2009 about 02.00 hours in the morning. The hospital building comprising a basement + 3 floors is located on a plot surrounded by empty car parking lots allowing fire engines to respond easily (Figure 3). The building is surrounded by open areas facilitating easy response by fire engines. However vehicles parked along the street obstruct the access of fire engines to the building.

Figure 3. Bursa Şevket Yılmaz Hospital
(Şekil 3. Bursa Şevket Yılmaz Devlet Hastanesi [15])

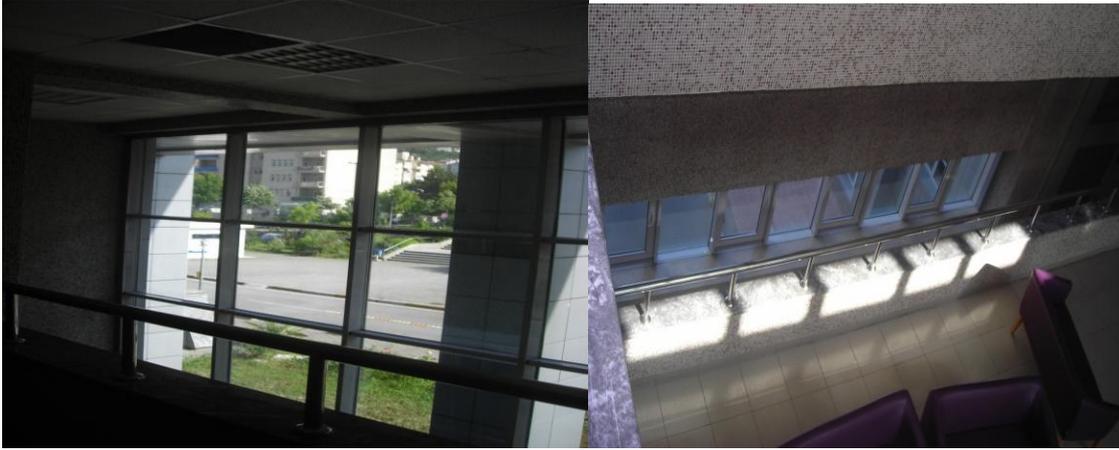
Figure 4. Şevket Yılmaz Hospital, Windows overlooking the gallery space

The smoke had spread to all floors through vertical ducting shafts, the spaces between suspended ceilings, galleries, the stairwell and the elevator well. The cloud of smoke which has covered the entire building has reduced visibility making the evacuation process difficult. The windows facing the galleries were tried to be opened to discharge the smoke but due to the large distance between the floor and the windows, the windows could not be reached and it was not possible to discharge the smoke in the corridors (Figure 4). Evacuation was very difficult due to reduced visibility in the escape paths. The smoke which has covered the entire building not only obstructed evacuation but it was also the main cause of the deaths. Although the fire originated in the basement most of the casualties were experienced in the intensive care unit on the 3rd floor. All the smoke was spread into this unit as a result of the ducting shafts acting as a tunnel for transmitting the smoke between the tomography center and the intensive care units. The shafts were fitted with non-smoke proof wooden gates increasing the magnitude of the disaster (Figure 5). The non-smoke proof wooden shaft gates opening to the intensive care unit have caught fire due to high temperature and the fire had spread quickly in the intensive care units after the stretcher made from highly inflammable materials, which was located in front of the door was ignited. The coating of the stretcher emitted toxic gases increasing the magnitude of the disaster. Moreover the number of casualties was increased due to the fact that patients with no mobility, surviving through life support units were located in this room [8].

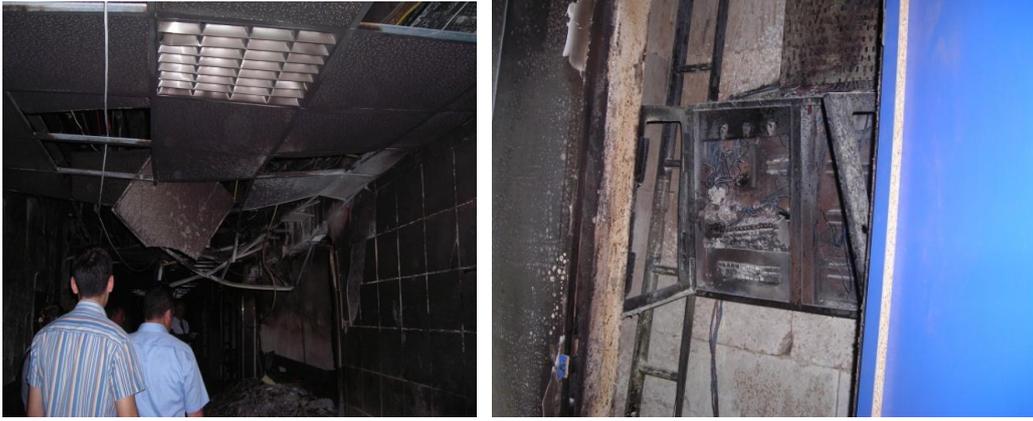
Figure 5. Sevket Yılmaz Hospital, CT center and plumbing shafts
(Şimşek arşiv 2009)
(Şekil 5. Şevket Yılmaz Hastanesi, tomografi merkezi ve tesisat
şaftları)

The fact that both electrical wiring and piping for vesicant gases such as oxygen, accelerating the burning process, were installed in the same ducting shaft with the dimensions of 165x65 cm is another important factor which contributed to the spread of the fire to the intensive care center which was located on the 3rd floor. Moreover the doors of fire escape stairs were locked for security purposes delaying vertical evacuation.

- o Vertical shafts and suspended ceilings must be sealed with materials that expand and prevent the passage of smoke through vertical shafts.
- o All fire doors must be fitted with an automatic closing mechanism and must be smoke proof. All ducting shafts must open to corridors and be fitted with smoke proof gates. Electrical wiring and piping for vesicant gases such as oxygen accelerating the burning process must be installed in independent shafts. Flame retardant halogen free cables must be used in electrical wiring [4].
- o A hospital specific emergency directive and plan must be prepared and evacuation practices must be made.
